Case Histories in Trenchless Excavation

Peter J. Tarkoy, Ph.D.

GeoConSol, Inc., Medfield, Massachusetts

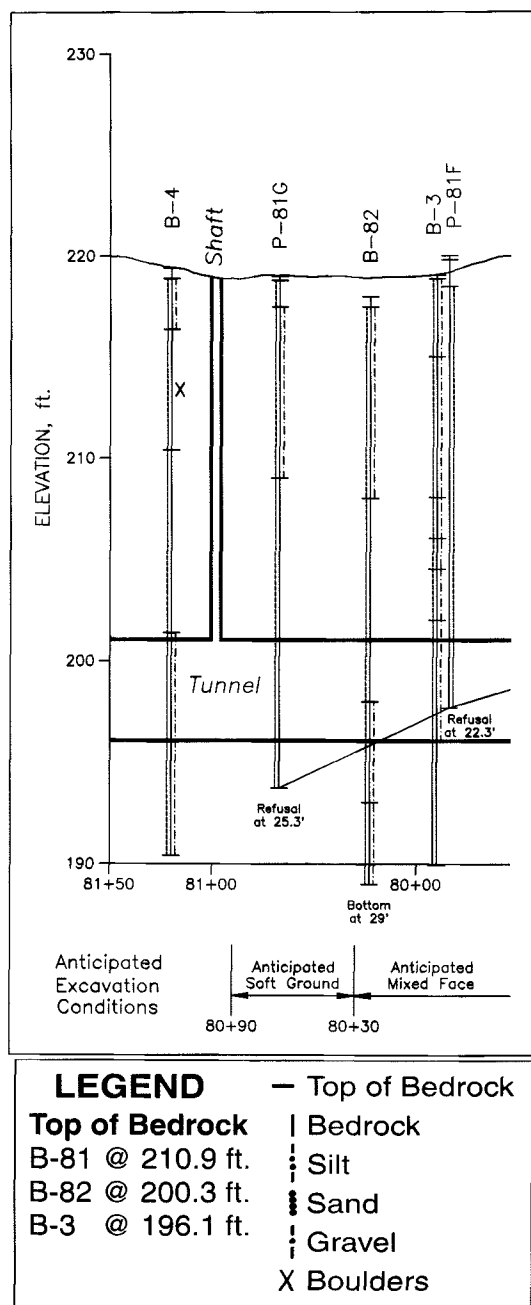
Figure 1: Soil Boring Profile of Anticipated Conditions

Figure 1 presents a soil boring profile of anticipated conditions. A buried valley (indicated by the sloping rock surface to the left of boring P-81F) remained largely unexplored and boulders were noted only in one instance (Boring B-4, drilled by one of the bidders) at a shallow depth (five ft). No boulders were encountered, noted, or anticipated at the pipe-jacking horizon.

The top-of-the rock was explored by a percussion drill, without the benefit of samples. Consequently, no differentiation could be made whether refusal meant boulders or the top of rock. The percussion holes were actually drilled to locate the top of rock and refusal was accepted as such.

The "refusal" or top-of-rock line was never re-evaluated by the engineer even though B-82 (drilled by one of the bidders) very notably conflicted with the rock line.

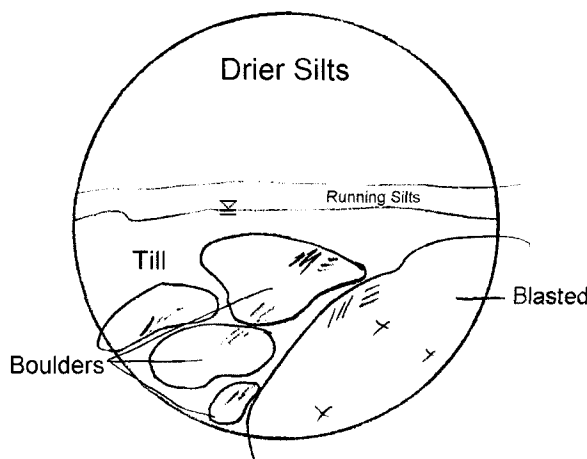
Figure 2: Unforeseen Boulder Pavement in Pipe-Jacked Excavation.

The encountered conditions are illustrated in a sketch of the pipe-jacking face in Figure 2. The pipe-jacking operation through the buried valley encountered what may be described as a "boulder pavement" or "nested boulders." The large volume of large boulders required excessive excavation outside the pipe. The encountered boulders were unusual in that they were large, continuous, and in layers.

Boulders that are largely outside the outer perimeter of the pipe have to be blasted in the hope that breakage extends far enough outside the perimeter to allow the pipe to pass without being damaged. In the case illustrated in Figure 2,

the situation was complicated by the presence of unstable flowing silts overlaying the boulders that could not be dewatered from the surface.

The upper part of the face had to be breasted from within the excavation while an attempt was made to remove boulders without losing the face. Most commonly, the face was consolidated by grouting on one shift and the boulders mined on the following shift, and the face advanced through the stabilized silt on the following shift.

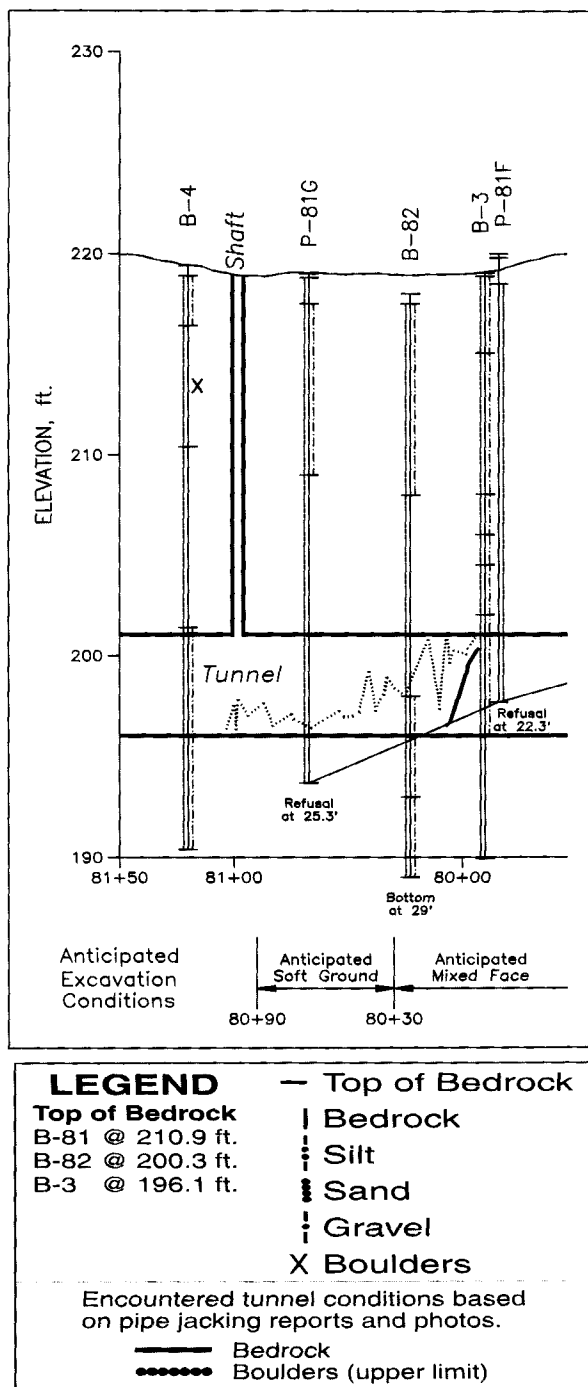
Figure 3: Anticipated and Encountered Rock Profile

illustrated in Figure 3. The engineer selected top of rock based on sampling in the borings (B-80 series) and refusal of auger probes (P series). Anticipated conditions in the geotechnical report and summarized at the bottom of the profile (Figure 3) were inconsistent with boring B-82. The inconsistency manifests in P-81F&G and B-82 and suggests that refusal in P-81G may be a boulder since B-82 extends four ft beyond refusal in P-81G.

by the engineer to revise the profile even though the inconsistency became even more pronounced with B-3 encountering rock at the invert of the proposed excavation and above the rock line in Figure 3.

The crown of the rock tunnel excavation continually penetrated into the soil horizon that was lower than anticipated and resulted in a more extensive mixed-face mining than anticipated. The pipe-jacking operation encountered the top of rock earlier and higher than indicated by the geotechnical report (Figure 3). The progress rate in both headings suffered.

The pipe-jacking heading anticipated a small amount of rock in the lower portion of the excavation as indicated in Figure 3. However, the encountered rock rose higher and more steeply to a full face, necessitating abandoning the pipe-jacking method much earlier than anticipated. The encountered boulders and top of rock are illustrated in Figure 4.

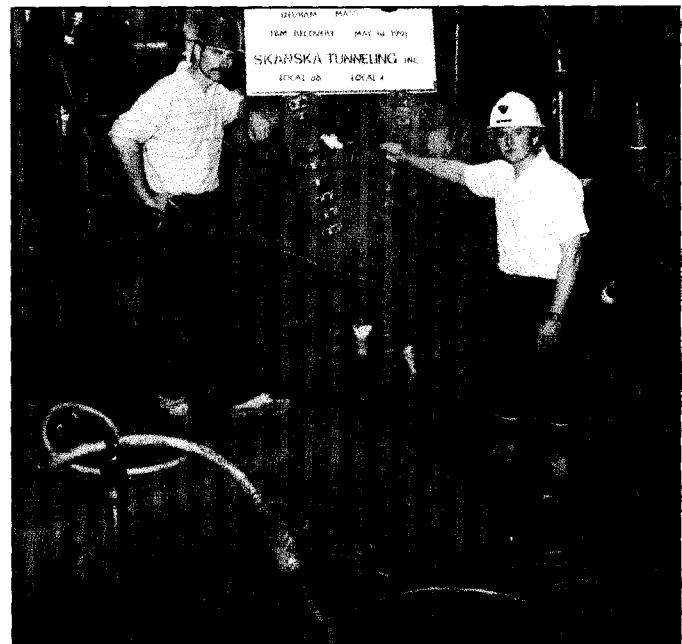
Figure 4: Rock Slab Encountered by Microtunneling

In another case involving unanticipated rock, the consequences were much more serious. A closed face, small diameter microtunneling machine encountered what was originally thought to be a boulder; however, upon excavation, it turned out to be a rock slab (Figure 4) that may have slid off an adjacent slope of the buried valley.

Specifications originally called for excavation without surface disruption. When the tunneling machine was halted by the slab of rock, it became necessary to dig up the street to rescue the halted machine after an eight-month delay.

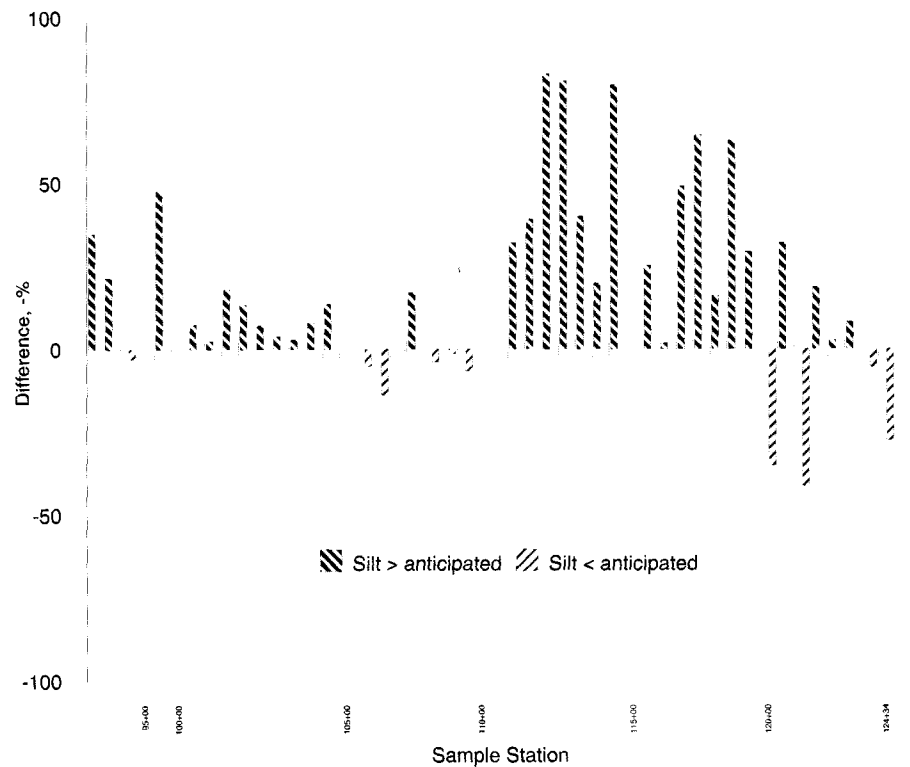
Figure 5: Anticipated and Encountered Silt Content.

The first sign of difficulties manifested when it was discovered that the installed dewatering system could not lower the water level as required. Sieve analyses of samples taken from the trenches, the pipe-jacked face, and

dewatering wells indicated a much higher than anticipated silt content (Figure 5),

The sieve analyses and field experience confirmed that the encountered material consisted of (sandy) silt which was cohesive and hard when dry and flowed when wet, could not be dewatered by the installed system, could only be stabilized by chemical grouting, required daily breasting of the face, and made the excavation of boulders and higher than anticipated top-of-rock more difficult.

When dry the silt was hard and required blasting. When wet, or allowed to stand overnight, the silt flowed like thick soup and it posed a stability problem at the pipe-jacked heading.

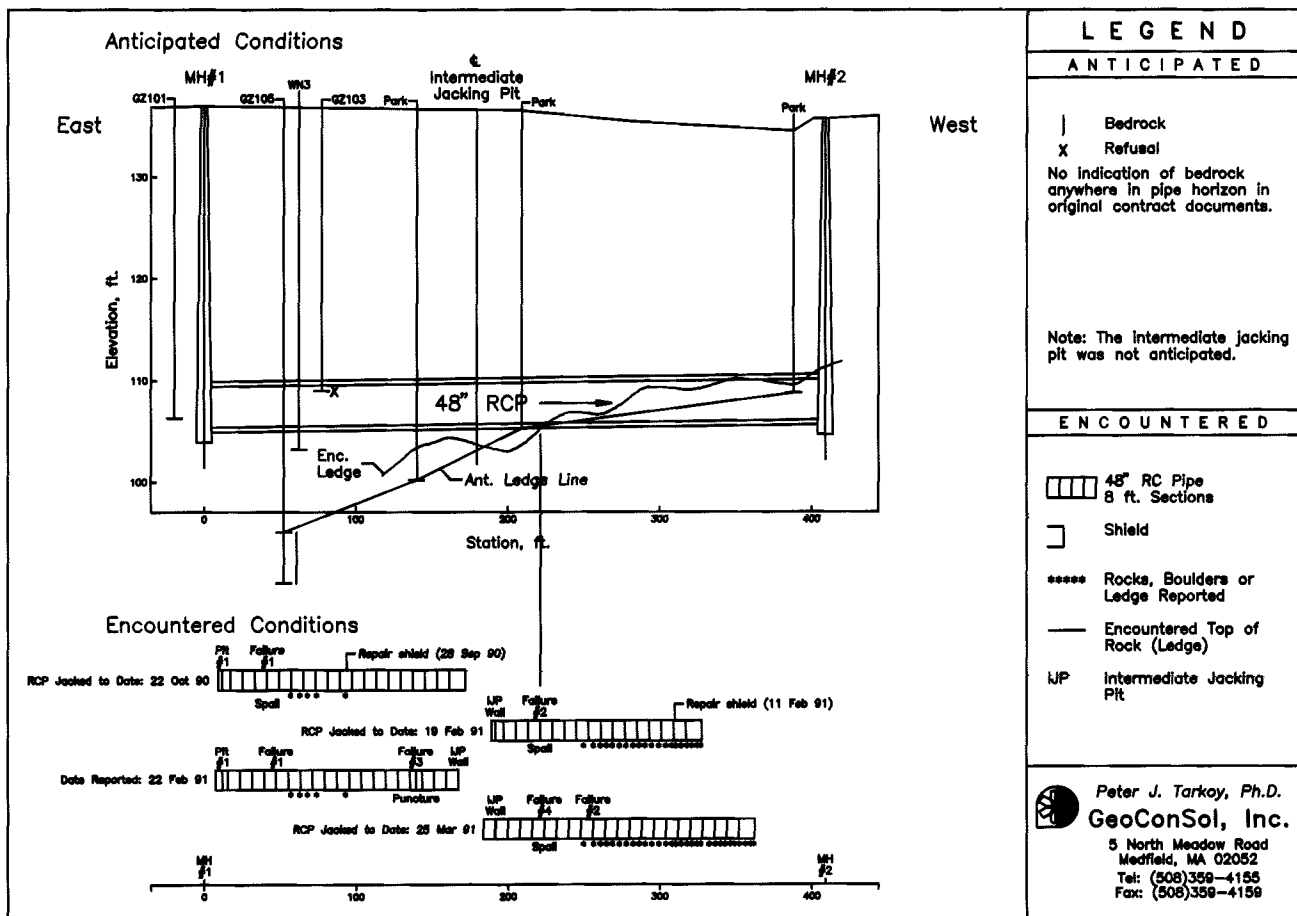
Figure 6: Profile of Jacked Pipe Failures

Several cases of pre-cast concrete jacked pipe failure prompted an investigation that shed light on common phenomena in pipe jacking. The investigation examined the properties of the pipe itself and the construction process. Even though the maximum axial load on the pipe was less than one third of the ultimate strength of the concrete, consistent with industry experience without pipe failure,

and consistent with the recommendations of the Concrete Pipe Handbook, sections of pipe failed on several occasions. Investigation of the construction process uncovered several notable facts, such as highest stresses were naturally on the last section of pipe installed in the jacking pit where no failures occurred. Failures occurred after week-ends and holidays, were coincidental with noted pipe misalignments, and where boulders and/or rock had been encountered. Stresses on the pipe at failure were less than the uniaxial strength of the concrete, and the pipe strength was within required tolerances.

It becomes obvious that the failure of the pipe could be related to less than ideal bentonite lubrication; failure to clear out obstruction (boulders and rock) around the pipe; failure to observe and respond to high jacking pressures; failure to correct misalignment of the pipe; and inadequate care during startup after a long hiatus of jacking.

In one instance, failure to adequately clear obstacles around the pipe resulted in a boulder puncturing the wall of the pipe.
