Responsible foundations

US-based geotechnical consultant Dr Peter Tarkoy maintains that identifying and categorising dangers can minimise accidents during tunnel construction

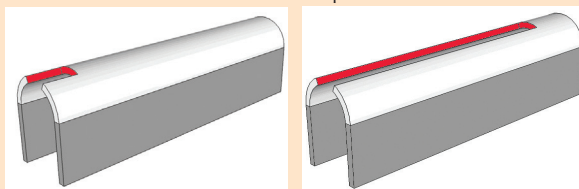
The length of excavation was limited to 3m-sections (Figure 1a) to allow concrete removal, rock excavation and installation of support, without placing the operator of equipment under the excavated crown. All equipment for the foregoing operations could reach the unsupported arch without exposing the operator to danger. However, once the contractor excavated, the absent resident

engineer allowed the excavation of 13m of crown (Figure 1b), thus placing the operator of the equipment under the unsupported arch. A slab of concrete dislodged, resulting in the death of the impact-hammer operator.

The extensive exposure of unsupported tunnel constituted both an eminent and an imminent danger, with no protection provided to the machine operator. The role of GeoConSol geotechnical and tunnel consultants was to confirm that the design engineer had no responsibility for the accident. The contractor's insurance company settled with the plaintiff.

Fig 1a (left): excavation limited to 3m sections;

Fig 1b (right): excavation of 13m of crown, leading to death of worker beneath unsupported arch

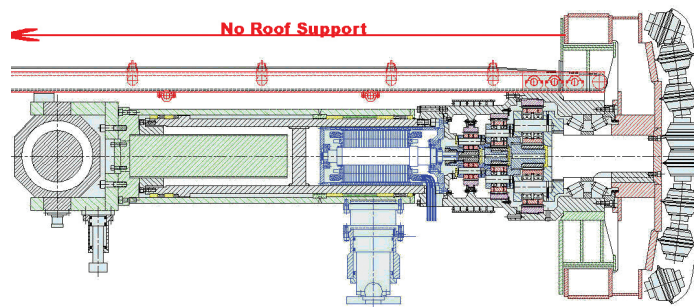
Fig 2: an open TBM design

Rock bolts were being installed at a distance in excess of 10m behind the exposure of the rock crown. A similar open TBM design is illustrated in Figure 2. Needless to say, the tunnel crown slabs were able to loosen along the bedding over the 10m distance. In this case, a slab fell on the labourer installing rock bolts behind the end of the primary conveyor, resulting in the loss of his leg.

The project geotechnical engineer failed to alert the tunnel designer and tunnel contractor of very likely fallouts of tunnel crown slabs resulting from sub-horizontal bedding planes. Had local geotechnical conditions been adequately identified, the designer could have prevented the injurious fallout by requiring in the specifications the immediate temporary support behind the cutterhead.

inherently an 'eminent' danger. The elimination of the imminent danger would have required a roof shield or temporary support installed behind the cutterhead. Neither of these methods to eliminate imminent danger were utilised because the eminent danger had not been identified and the means and methods had not been designed

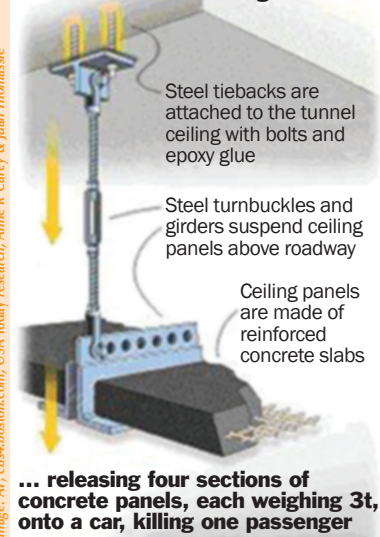
A suspended ceiling enclosing a ventilation space comprised 3t reinforced concrete panels supported by single steel tieback bolts secured by epoxy glue into the concrete structural ceiling (Figure 3). The bolts and glue failed, four ceiling panels fell, and caused the death of an automobile passenger.

It is clear that a single structural element (imminent danger) supported the 3t panels over an active roadway (eminent danger). Furthermore, the epoxy and bolts were never intended for this type of application.

Fig 3: mechanism of failure showing support elements and collapse of false ceiling

Tieback bolts pulled free from the tunnel's concrete ceiling...
